Visual Quality Discipline Report

Washington State Department of Transportation
Southwest Region
11018 NE 51st Circle
Vancouver, WA 98682-6686

July 2008

This project is also referred to as "SR 502/I-5 to Battle Ground – Add Lanes".

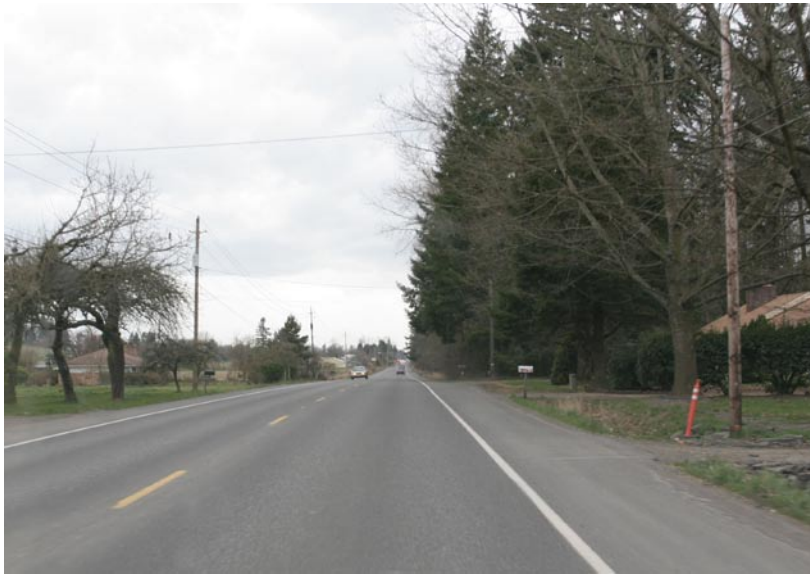
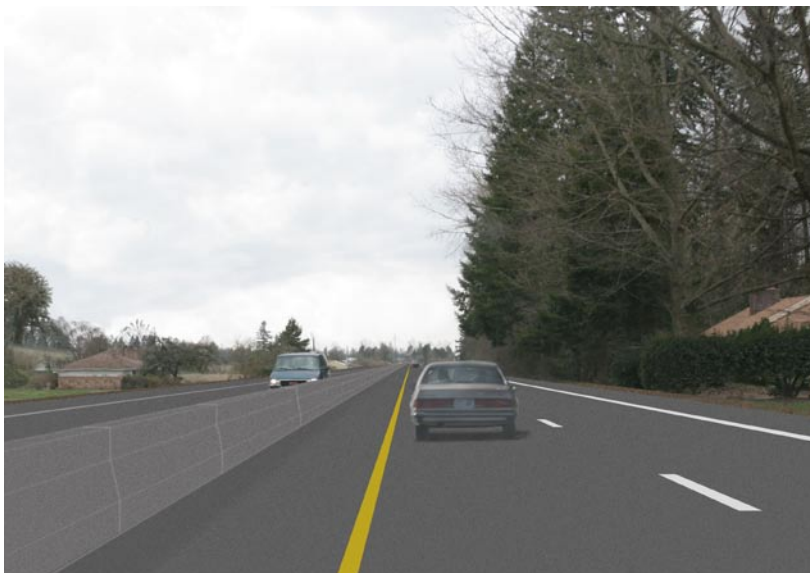
Exhibit 3 Photo Simulation Showing Approximate Visual Change in Landscape Unit D

The visual effects in Landscape Unit D would be very similar to those in Landscape Unit A. Please see the Landscape Unit A discussion above. A photo simulation shows the approximate visual change that would occur at the east end of Landscape Unit D (Exhibit 3).

EXISTING VIEW
SR 502 Looking West from NE 102nd Avenue

PROPOSED VIEW
SR 502 Looking West from NE 102nd Avenue

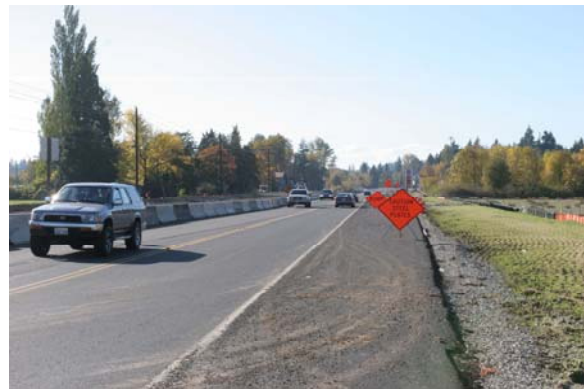
An example of construction signs, fencing, and median barrier used during construction of the I-5/SR 502 Interchange project.

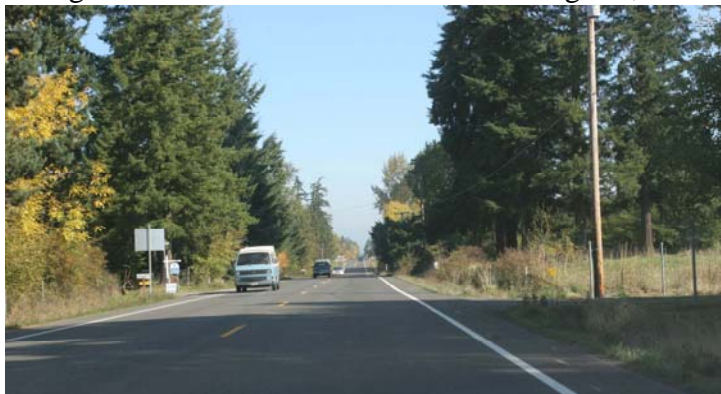
Effects to vegetation would include the removal of grass, shrubs, and trees immediately adjacent to SR 502 for road widening. In View 1 shown to the left, this would result in a wider visual corridor ahead of viewers, with pavement becoming more dominant in the view.

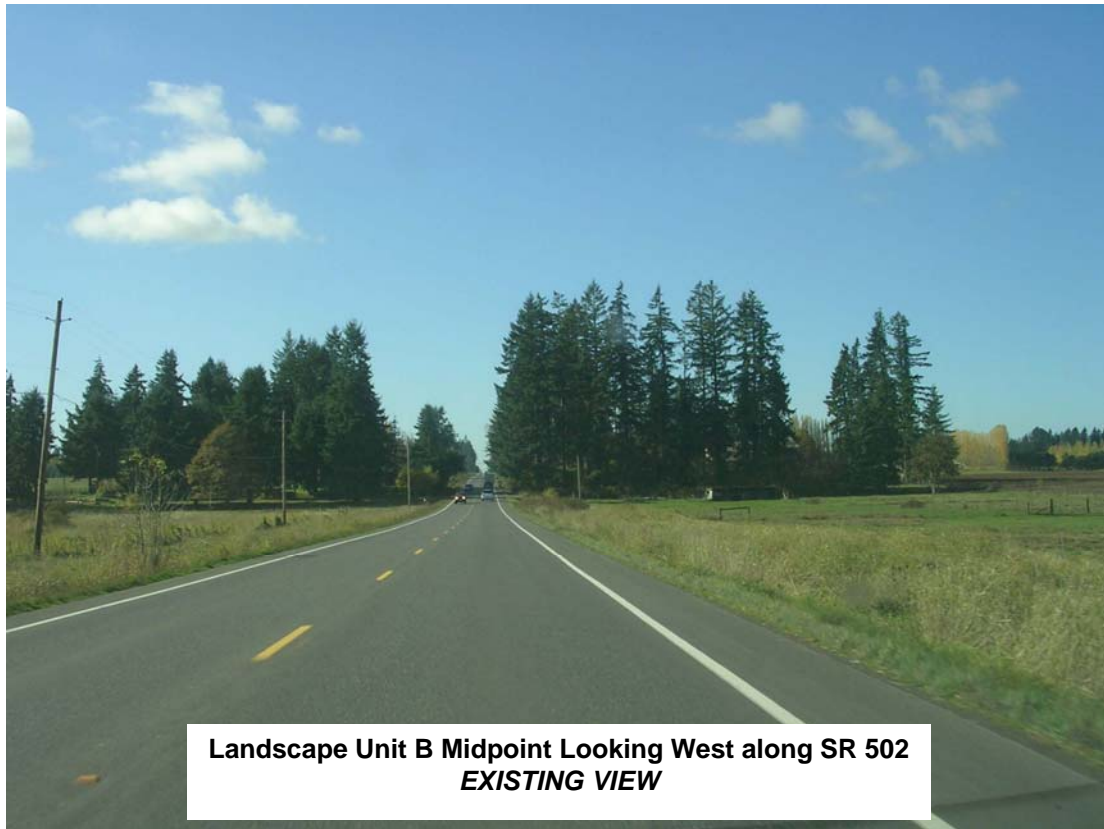
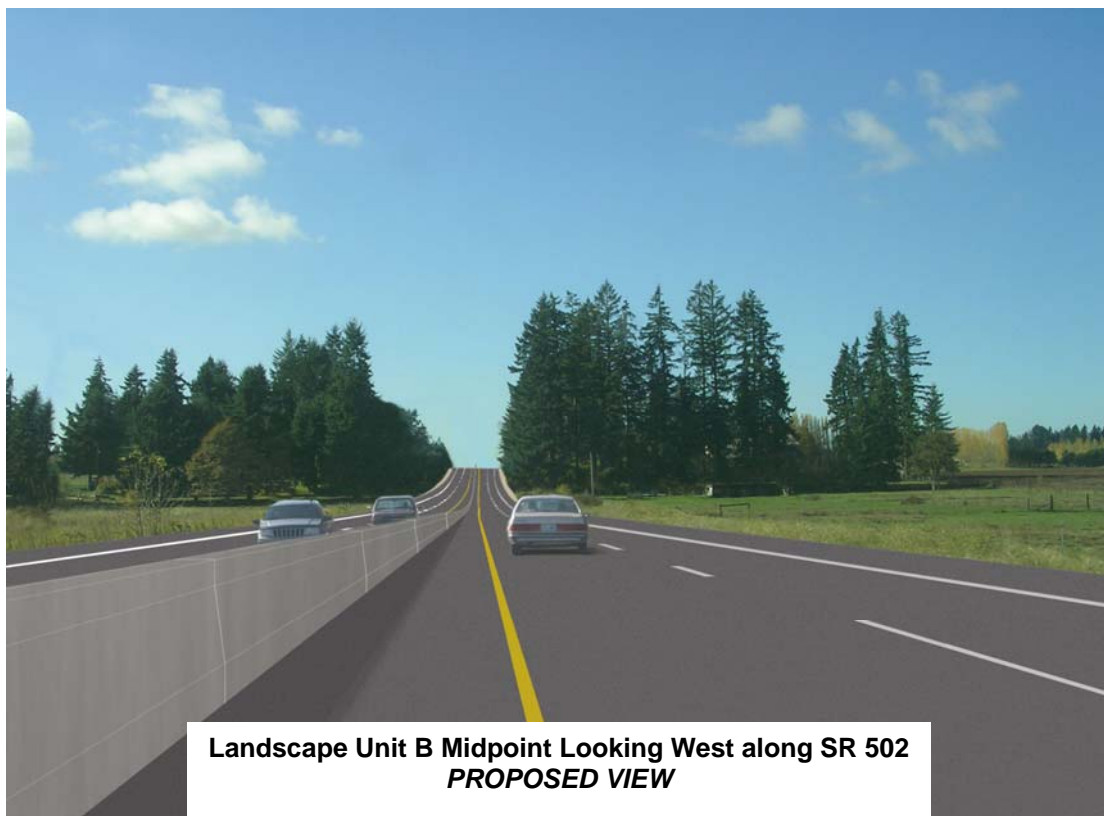
Exhibit 6. Landscape Unit B Simulation – Existing and Proposed Views

Effects to landform in Landscape Unit B would include fill material added to either side of the existing road to support the widened highway. The widened highway would have a similar vertical profile to the existing conditions so landform would not experience a noticeable difference. Vegetation, particularly grasses and shrubs, would be removed on either side of SR 502. In addition, a number of deciduous and coniferous trees would be removed immediately adjacent to the road on the east and west ends of the landscape unit. Visible effects to water resources are not anticipated as a result of the culvert replacement under SR 502.

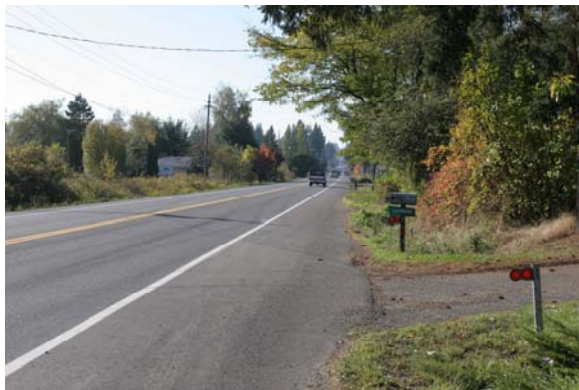
Effects to vegetation would include the removal of grass, shrubs, and trees immediately adjacent to SR 502 for road widening. In View 16 shown to the left, this would result in a wider visual corridor ahead of viewers, with pavement becoming more dominant in the view.
